Aviation Investigation Preliminary Report

Location:	Pierre, SD	Accident Number:	CEN24LA020
Date & Time:	October 23, 2023, 16:11 Local	Registration:	N92884
Aircraft:	Piper PA 46-350P	Injuries:	1 Fatal, 1 Serious
Flight Conducted Under:	Part 91: General aviation - Personal

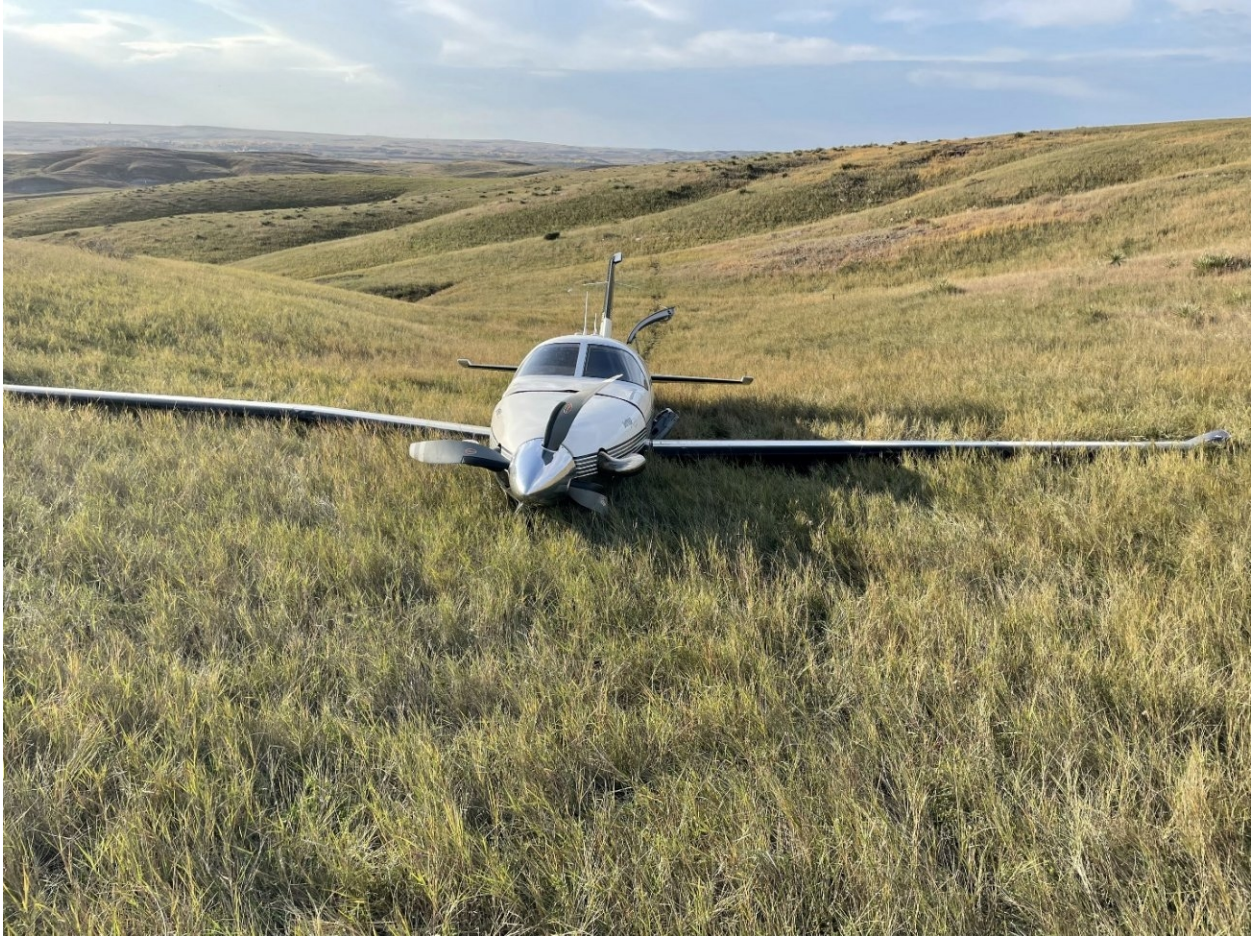
Figure 1. Airplane as it came to rest in the rolling terrain.

The airplane came to rest upright and sustained substantial damage to the fuselage and both wings.
