Aviation Investigation Preliminary Report

| Location: | Yuma, AZ | Accident Number: | WPR24LA038 |
| Date & Time: | November 17, 2023, 20:30 Local | Registration: | N2024C |
| Aircraft: | Beech 95 | Injuries: | 2 None |

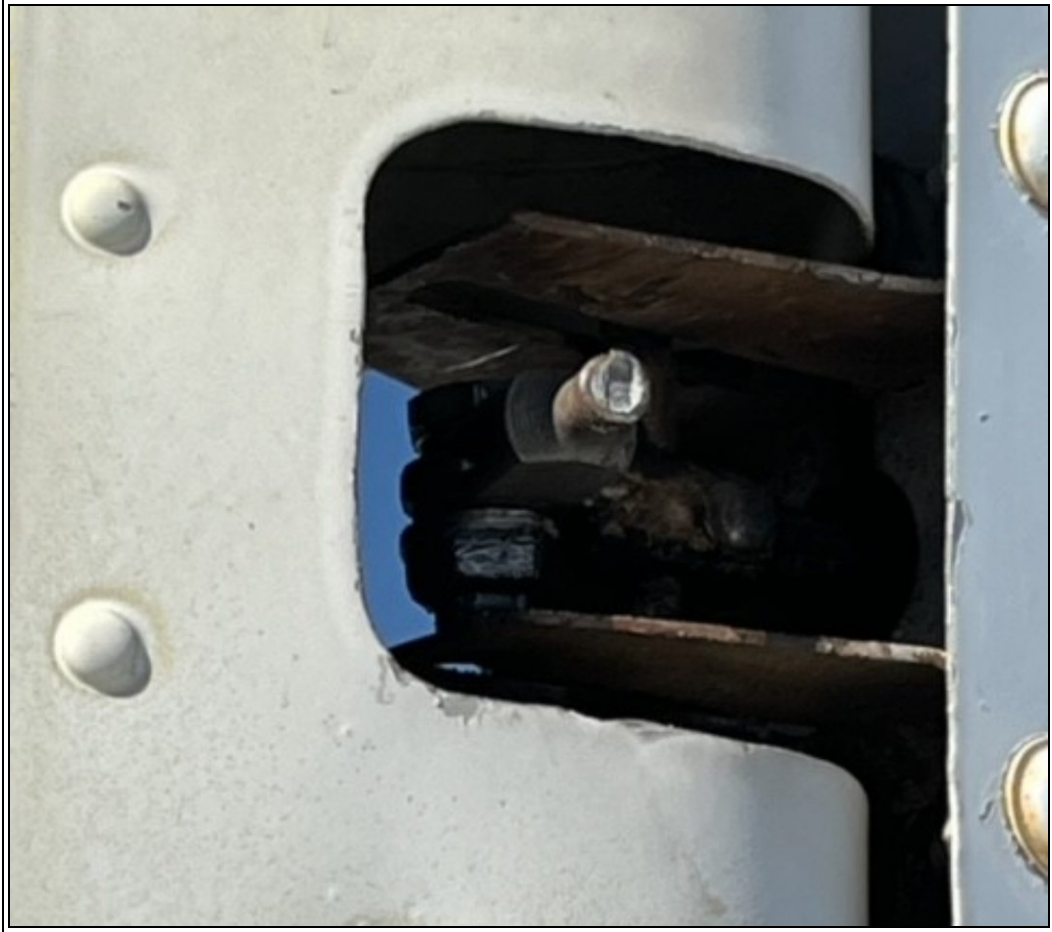
Postaccident examination of the airplane by a Federal Aviation Administration inspector revealed that the rudder trim tab rod was fracture separated near the trim tab attachment point and the forward windshield had separated which resulted in substantial damage. The wreckage was recovered for further examination.

Figure 1: View of damaged rudder trim tab rod end (photo courtesy of the FAA)
