Aviation Investigation Preliminary Report

Location:	Topock, AZ	Accident Number:	WPR24FA054
Date & Time:	December 10, 2023, 15:55 Local	Registration:	N4171S
Aircraft:	Beech A36	Injuries:	1 Fatal
Flight Conducted Under:	Part 91: General aviation - Personal

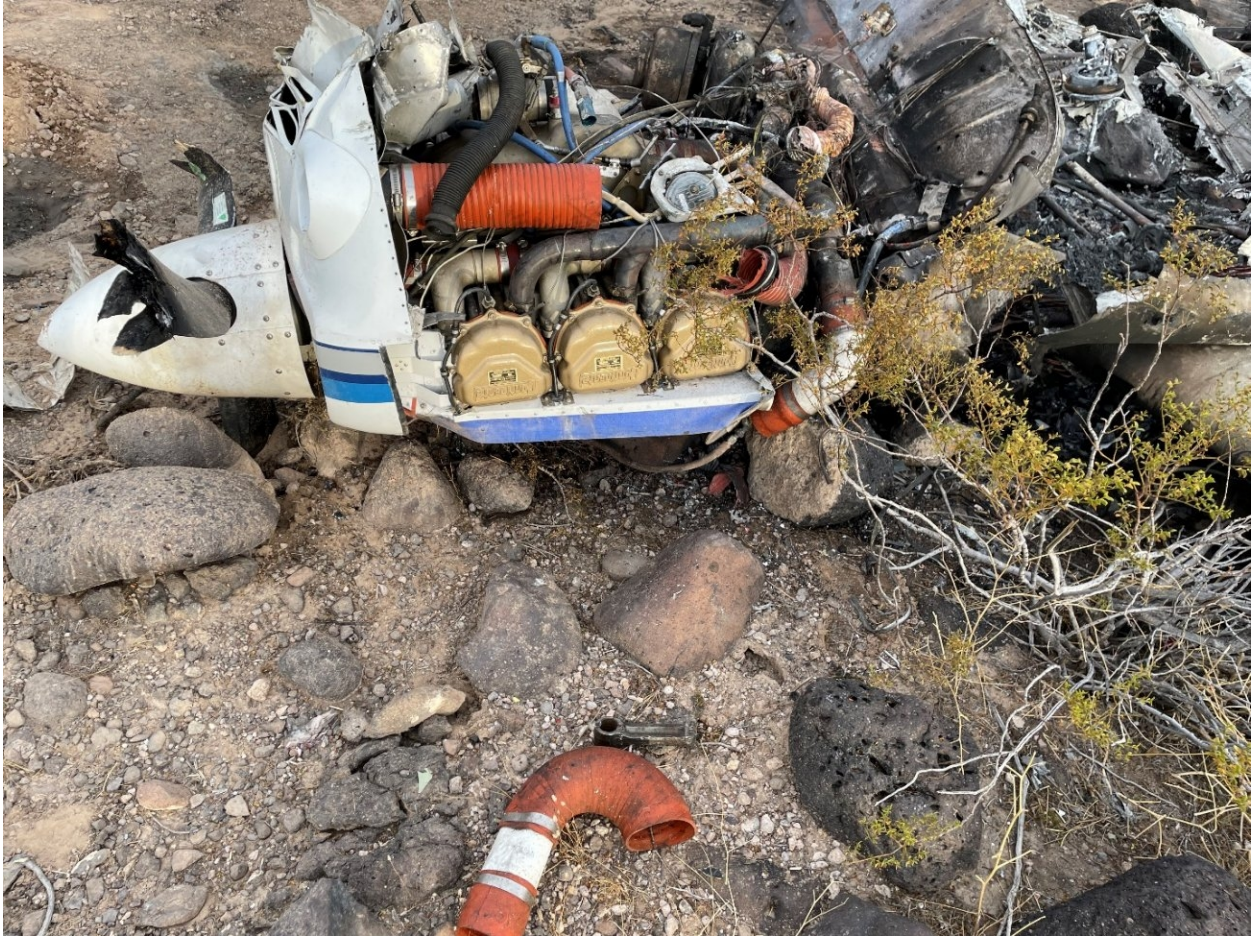
The airplane subsequently impacted rocky desert terrain near an unimproved road. A post impact fire consumed the cockpit, right wing, and a portion of the fuselage. The empennage sustained minor damage and flight control continuity was confirmed from the cabin to each of the flight control surfaces. The engine remained attached to the airframe by avionics and control cables. A portion of the No. 4 cylinder piston connecting rod was found outside of the crankcase when the engine cowling was removed.

Figure 1: Post-accident image of connecting rod on the ground next to engine (Courtesy of LEA)
