Aviation Investigation Preliminary Report

Location:	San Pedro, CA	Accident Number:	WPR23LA352
Date & Time:	September 25, 2023, 12:50 Local	Registration:	N135WT
Aircraft:	WAYNE TODDUN SLING 4 TSI	Injuries:	2 Serious
Flight Conducted Under:	Part 91: General aviation - Instructional

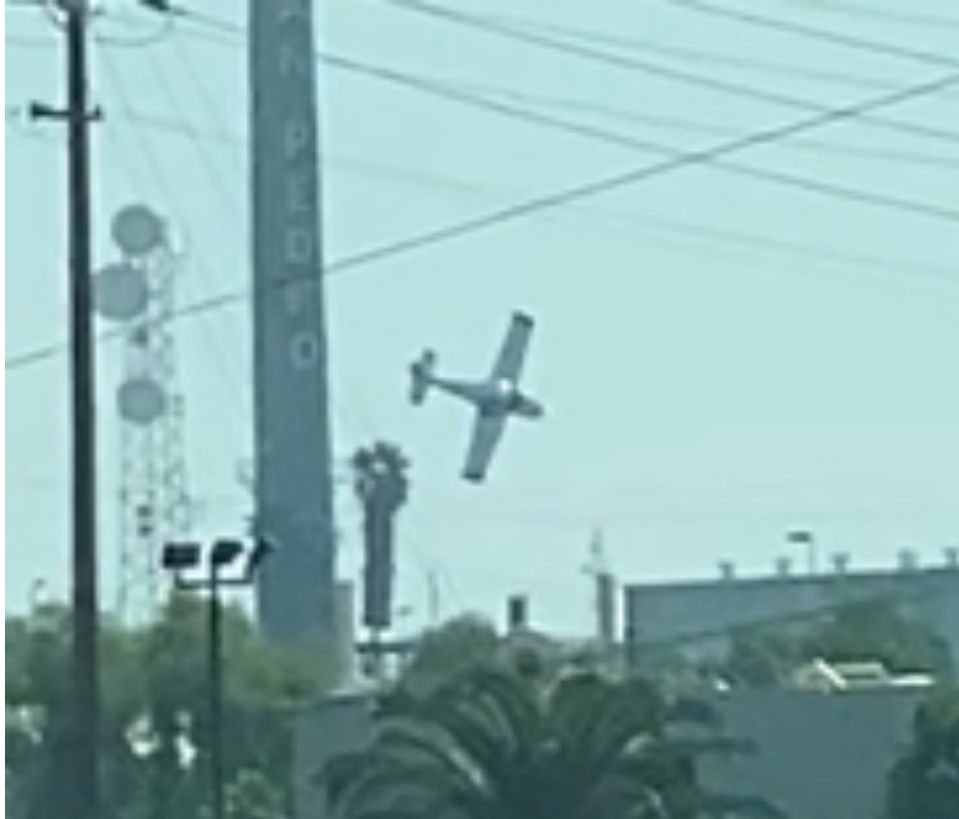
A witness video that recorded the accident flight from about 1249 showed a trail of white smoke behind the airplane as it maintained a northerly heading. Approximately 12 seconds later the smoke ceased and the airplane subsequently began a right descending turn. The airplane then entered a steep right turn in a nose down attitude and rapidly descended towards the ground as it disappeared from view.

Photograph 1: Accident airplane seconds before impact
