Thomas P. Turner's Mastery of Flight

FLYING LESSONS for March 28, 2024

What happened

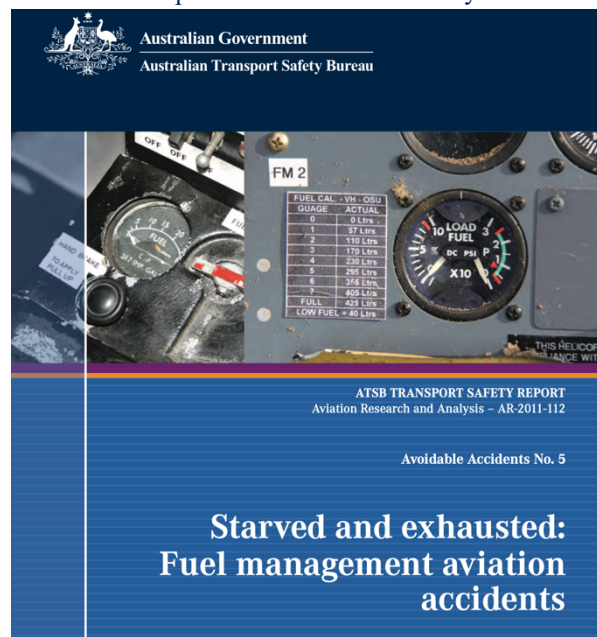
If you have any doubts, look at the cover of the ATSB report pictured above. Australian aircraft owners are required to have their fuel systems calibrated every three years and a placard installed on the panel adjacent to the gauges to show the actual fuel level (in liters) for each marking on the gauge. This tells us it *is* possible to maintain factory fuel indicating systems to a level they indicate accurately—or predictably close to accurate—across their entire indicating range.
