Aviation Investigation Preliminary Report

Location:	Arvada, CO	Accident Number:	CEN24FA212
Date & Time:	June 7, 2024, 09:30 Local	Registration:	N150WR
Aircraft:	Beech V35A	Injuries:	1 Fatal, 3 Serious
Flight Conducted Under:	Part 91: General aviation - Personal

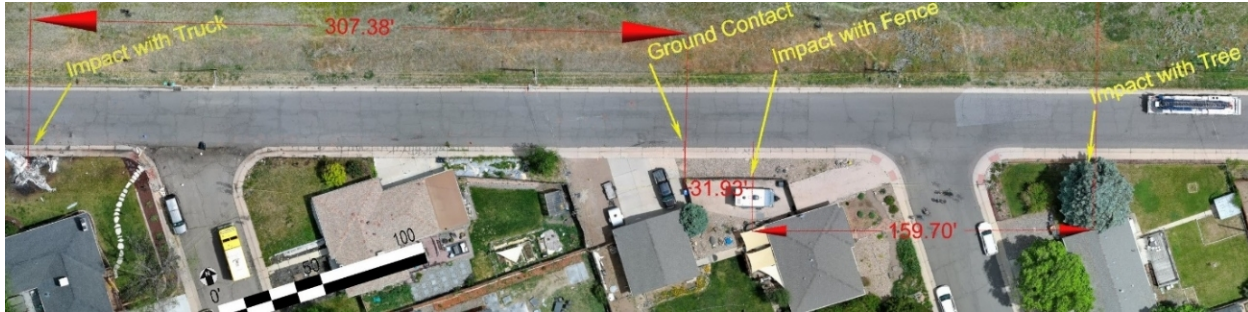
Examination of the accident site showed that the airplane’s left wingtip impacted a 30-ft tall tree adjacent to the roadway. Parts of the left wingtip were found in the roadway near the tree. Evidence at the accident site showed that the airplane contacted the roadway, gear up, and slid down the road until it collided with a parked vehicle and came to rest upright in the front yard of a private residence. Ground scars on the roadway were consistent with contact and scraping from the bottom of the fuselage. The distance traveled from the initial impact with the tree to the final resting place was about 400 ft. See Figure 1.

1. Accident Site
