# **Aviation Investigation Preliminary Report**

Location: Escalante, UT Accident Number: WPR24LA211

Date & Time: June 18, 2024, 20:09 Local Registration: N9NS

Aircraft: Beech 58P Injuries: 1 None

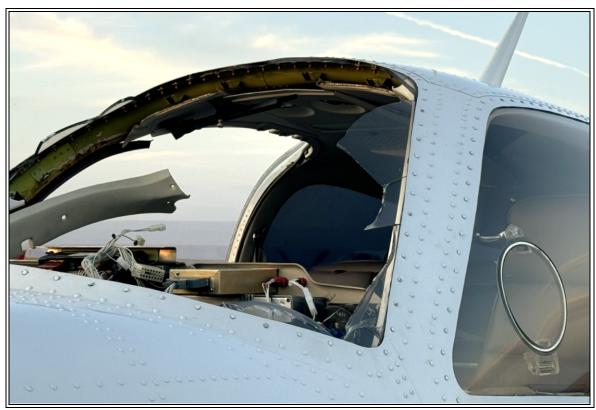
A post-accident examination revealed that portions of the windshield remained in the frame and the center area had departed the airplane (see Figure 1 below).

Figure 1: The Windshield After Landing
