# Aviation Investigation Preliminary Report

| <b>Location:</b> | Ronkonkoma, NY | <b>Accident Number:</b> | ERA24FA318 |
| <b>Date &amp; Time:</b> | July 22, 2024, 18:12 Local | <b>Registration:</b> | N1089W |
| <b>Aircraft:</b> | Beech A36 | <b>Injuries:</b> | 2 Fatal |

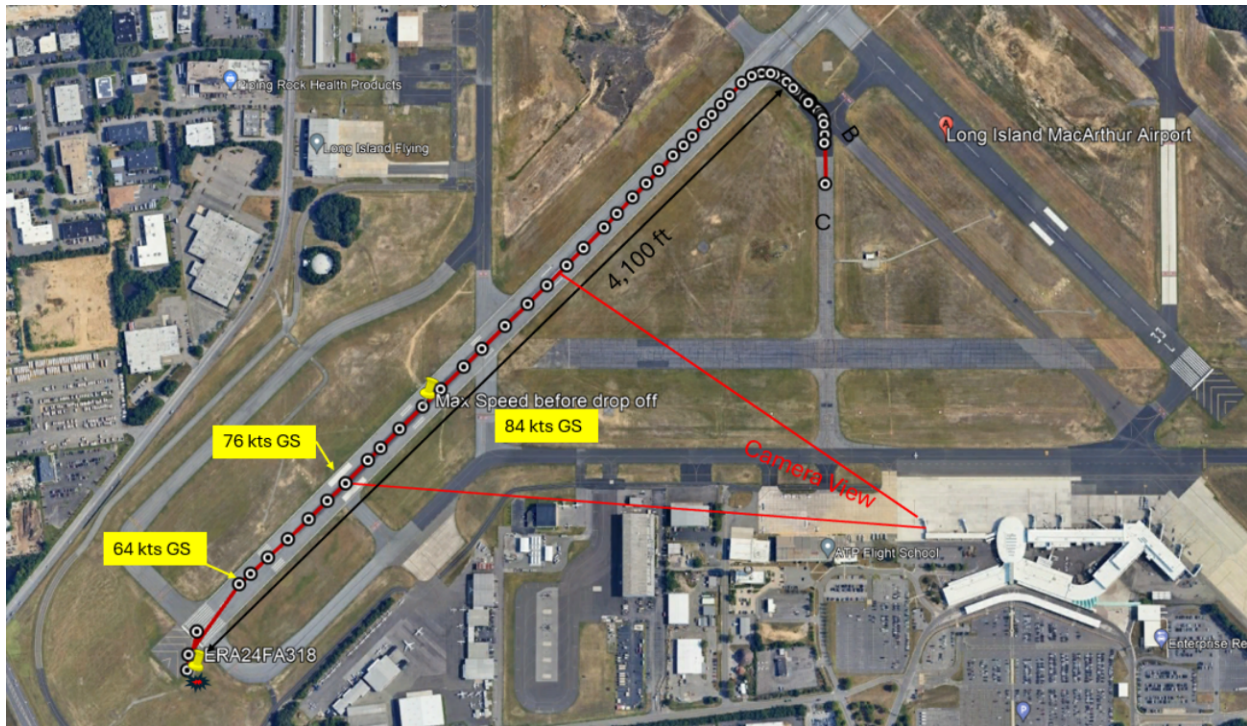
The pilot was departing from Long Island Mac Arthur Airport (ISP), Islip, New York, and taxied from the ramp via taxiways C to B to join runway 24 for an intersection takeoff at the 4,100 ft-remaining point of the 7,006 ft-long runway. Security video taken from a camera located at the airport terminal showed the airplane during the takeoff roll, liftoff, and initial climb, which all appeared normal. The landing gear retracted before the airplane disappeared out of the camera frame. Preliminary Automatic Dependent Surveillance-Broadcast (ADS-B) data provided by the Federal Aviation Administration (FAA) indicated that the takeoff roll was about 1,200 ft long prior to liftoff and that the groundspeed was about 82 kts during initial climb. Shortly after the landing gear were raised, the ground speed began to steadily decay to 62 kts before the airplane began a descending turn to the left. Figure 1 shows an aerial image of the ISP airport with the airplane's ground track overlaid.

Figure 1 - Preliminary ADS-B data with the airplane's track over runway 24 overlaid along with annotations of the airplane's ground speed.
