# Aviation Investigation Preliminary Report

<b>Location:</b>	Lafayette, LA	<b>Accident Number:</b>	CEN24FA353
<b>Date &amp; Time:</b>	September 12, 2024, 11:37 Local	<b>Registration:</b>	N643RS
<b>Aircraft:</b>	HAWKER BEECHCRAFT CORP G36	<b>Injuries:</b>	1 Fatal
<b>Flight Conducted Under:</b>	Part 91: General aviation - Personal

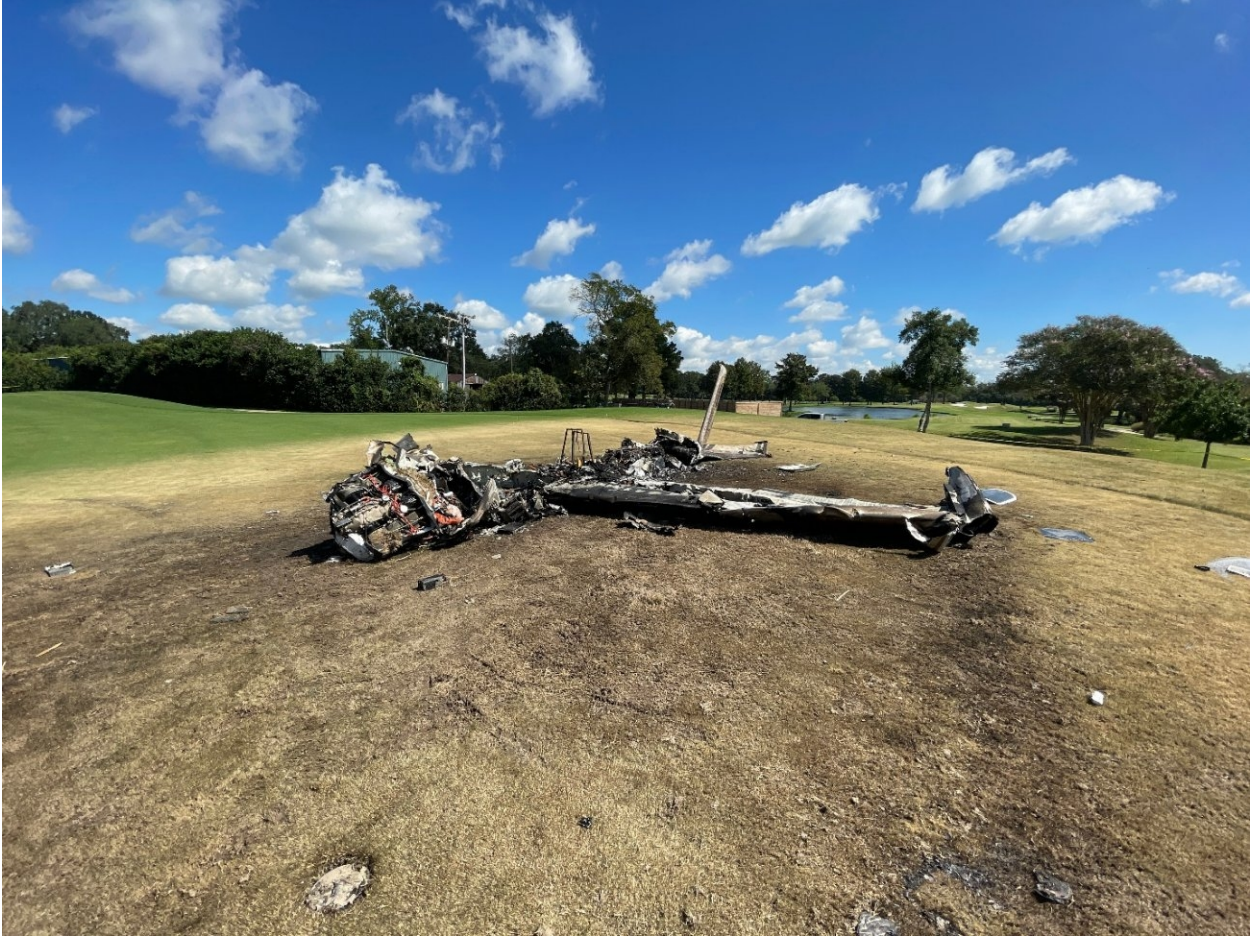
The airplane came to rest on a golf course fairway. There were broken tree limbs near the initial impact location. The wreckage debris path was oriented about 60 degree magnetic heading. The wreckage damage was consistent with a right-wing, nose-low impact. The wreckage debris path was about 150 ft from the initial ground scar to the resting place of the main wreckage. Fire consumed the majority of the fuselage cabin and inboard portions of both wings. The aft fuselage cone and tail surfaces were rotated about 90 degrees to the left. The vertical tail and right horizontal stabilizer remained attached to the aft fuselage. The left horizontal stabilizer was partially separated and folded beneath the aft fuselage. The elevators and rudder were still attached to their respective fixed surfaces.

Remains of both wings were located in their appropriate position relative to the fuselage remains. No evidence of an in-flight failure was noted. Both ailerons remained attached to the wings. The left flap was still attached to the wing. The right flap was almost completely consumed by the fire but the inboard portion remained attached to the wing. The airplane's flight control system was examined and no evidence of a flight control malfunction was found. The cabin section of the airplane was consumed by fire. Evidence of fire was found on the forward side of the firewall with burning and melting of components adjacent to the firewall.

Figure 2. An image of the airplane wreckage at the accident site.
