Aviation Investigation Preliminary Report

Location:	Broomfield, CO	Accident Number:	CEN25FA178
Date & Time:	May 17, 2025, 10:03 Local	Registration:	N4321Z
Aircraft:	Beech 95-B55 (T42A)	Injuries:	2 Fatal
Flight Conducted Under:	Part 91: General aviation - Personal

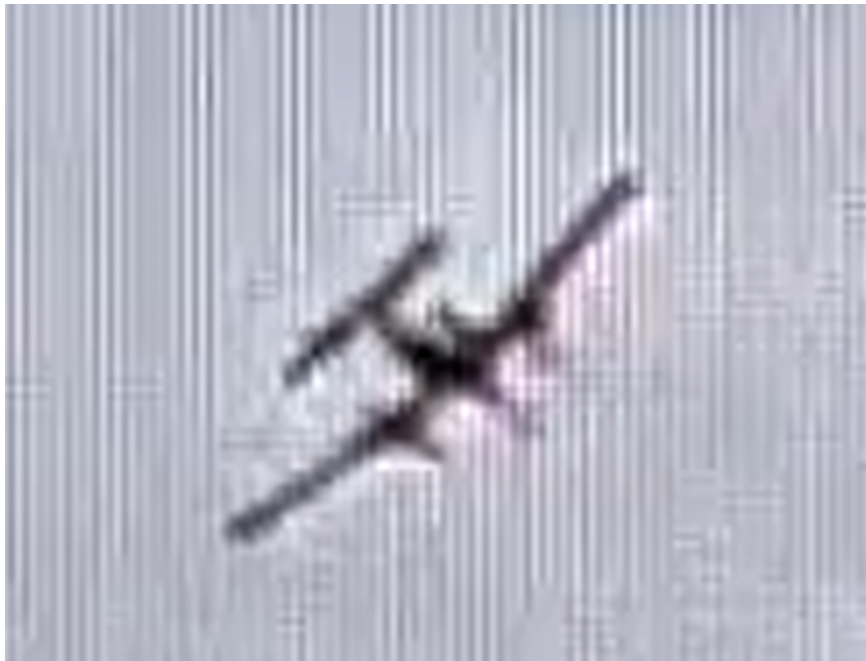
At 1002:49, surveillance camera video from a bus stop along U.S. Route 36, located near the right downwind traffic pattern leg, captured the airplane with the landing gear extended entering a left bank that increased in roll rate until the airplane was in an inverted left wing down and nose low dive at 1002:53. The surveillance video shows what appears to be an open door, consistent with the pilot's report to ATC (see Figure 1).

Figure 1. Surveillance camera video still image.

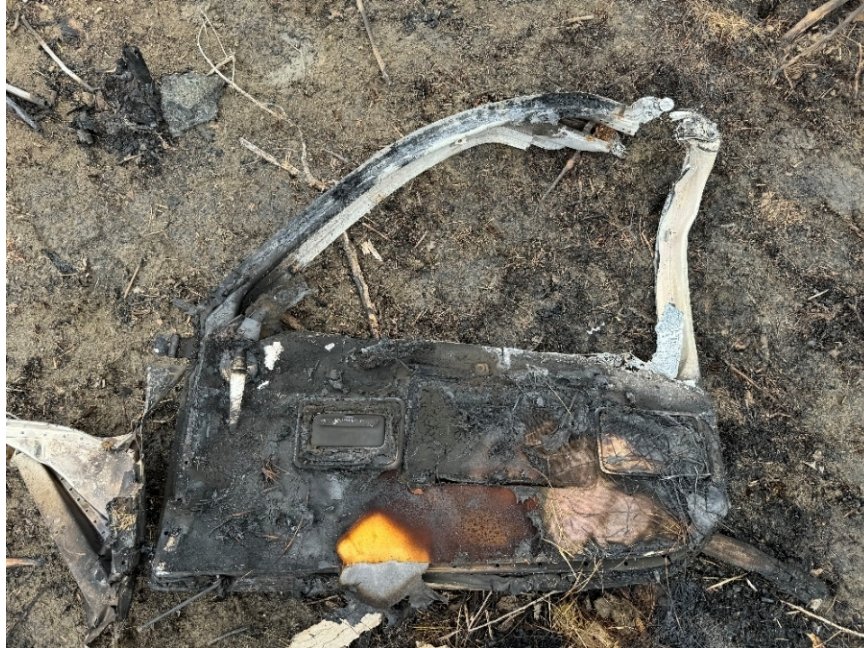
The main cabin door was separated from the airplane, located on the left side of the debris path, and the door handle was found in the open position (see Figure 2). The rear sloped latch, lower pin, and upper claw latch were found in the locked position.

Figure 2. Interior side of main cabin door
