Aviation Investigation Preliminary Report

| Location: | Tabor City, NC | Accident Number: | ERA25FA228 |
| Date & Time: | June 14, 2025, 12:45 Local | Registration: | N82UC |
| Aircraft: | Beech 58 | Injuries: | 2 Fatal |

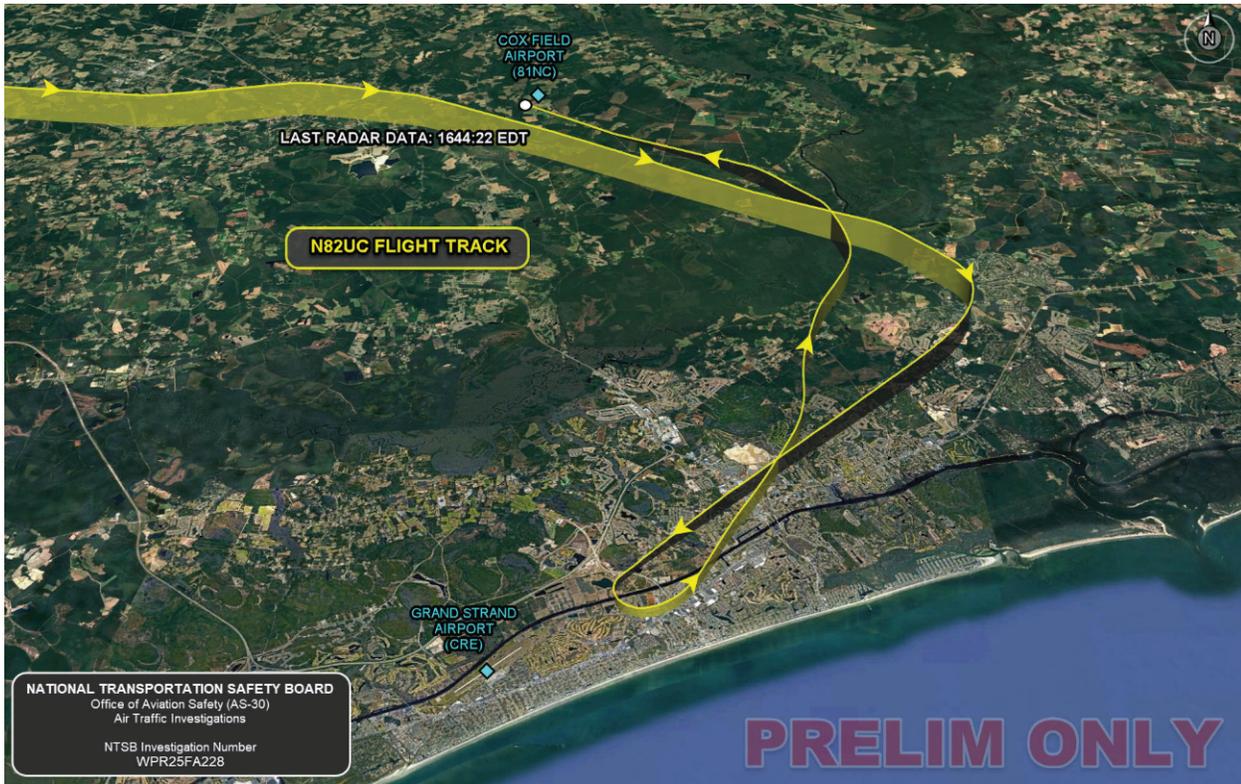
About 5 nm miles into the diversion, while at 3,000 ft msl, the pilot turned to a track of about 310° and began a descent; the airplane's speed increased steadily from 160 knots to about 235 knots groundspeed in a steady straight-line descent. The controller attempted to contact the pilot; however, there was no response. Multiple transmissions were heard that included engine noise and inaudible conversation, but there was no direct pilot-to-controller communication from this point forward. No other communications were received, and radar contact was subsequently lost. The airplane's descent rate went from -600 feet per minute (fpm) to -4,500 fpm until there was a brief arrest of the descent where it decreased to -300 fpm after which the descent rate increased again to -4,000 fpm until the ADS-B data ended. (Figure 1) During the final descent, there were no observed maneuvers or significant heading changes. The tree impact signatures at the accident site indicated a descent angle of about 23° and

Figure 1 Final flight path through arrival, approach, diversion and accident.

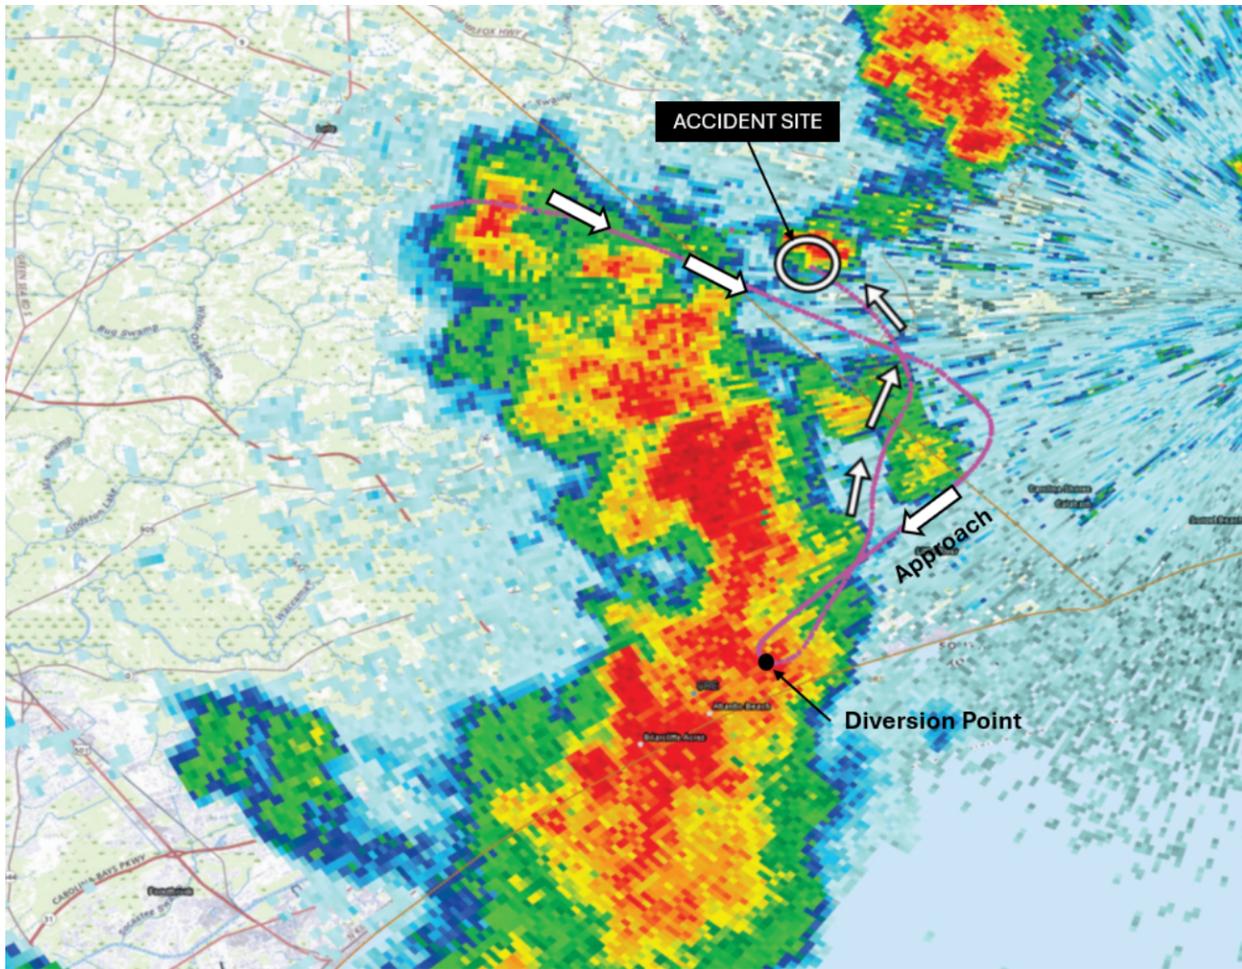
The reported weather conditions at CRE about 5 minutes before the accident included wind from 240° at 20 knots gusting to 30 knots, 1 1/2-mile visibility with heavy thunderstorms, rain, and mist. There were few clouds at 1,000 ft above ground level (agl) and scattered clouds at 2,100 ft agl. The reported temperature and dewpoint were 27° and 26° C, respectively.

At 1244, about the time of the accident, the reported wind was from 240° at 14 knots gusting to 27 knots, 3/4 mile visibility, heavy thunderstorms, rain and mist, few clouds at 800 ft, broken clouds at 1,800 ft and 5,000 ft agl and the reported temperature and dewpoint were 27° and 26° C, respectively.

Figure 2 Overview of final route of flight with flight track and weather.
