Aviation Investigation Preliminary Report

Location:	Eagle Nest, NM	Accident Number:	WPR25FA205
Date & Time:	July 6, 2025, 13:45 Local	Registration:	N5009B
Aircraft:	Beech F35	Injuries:	1 Fatal
Flight Conducted Under:	Part 91: General aviation - Personal

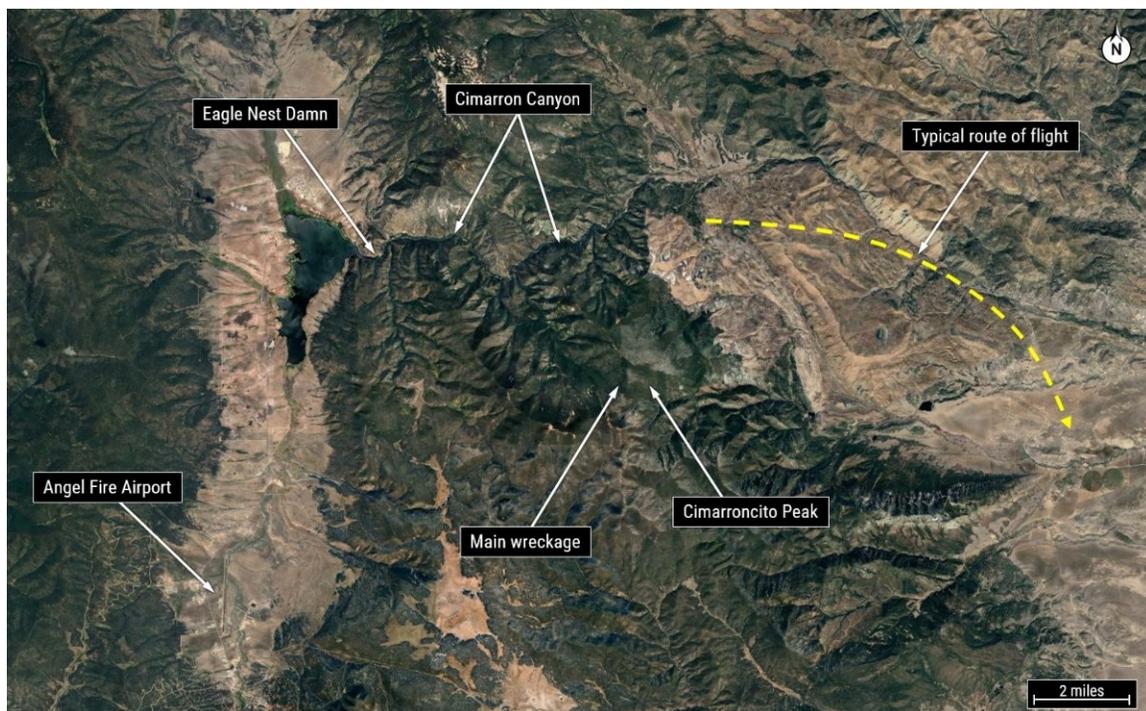
Angel Fire Airport was within a 5-mile-wide valley at an elevation of 8,380 ft msl. It was bound by mountain peaks reaching 11,721 ft to the east, and 13,161 ft to the west. According to family, after departure the pilot typically flew to the Eagle Nest Dam just to the north, and followed Cimarron Canyon through to the lower plains, about 20 miles east. From there he would fly south to Hobbs (see figure 1).

The airplane came to rest on a 30° slope at an elevation of 9,932 feet msl, at the end of a box canyon. It was about 500 ft below, and 2 miles west, of Cimarroncito Peak.

Figure 1 – Accident location and geographic features
