Aviation Investigation Preliminary Report

Location:	Englewood, CO	Accident Number:	CEN25FA366
Date & Time:	September 5, 2025, 06:23 Local	Registration:	N463T
Aircraft:	Beech P35	Injuries:	2 Fatal
Flight Conducted Under:	Part 91: General aviation - Instructional

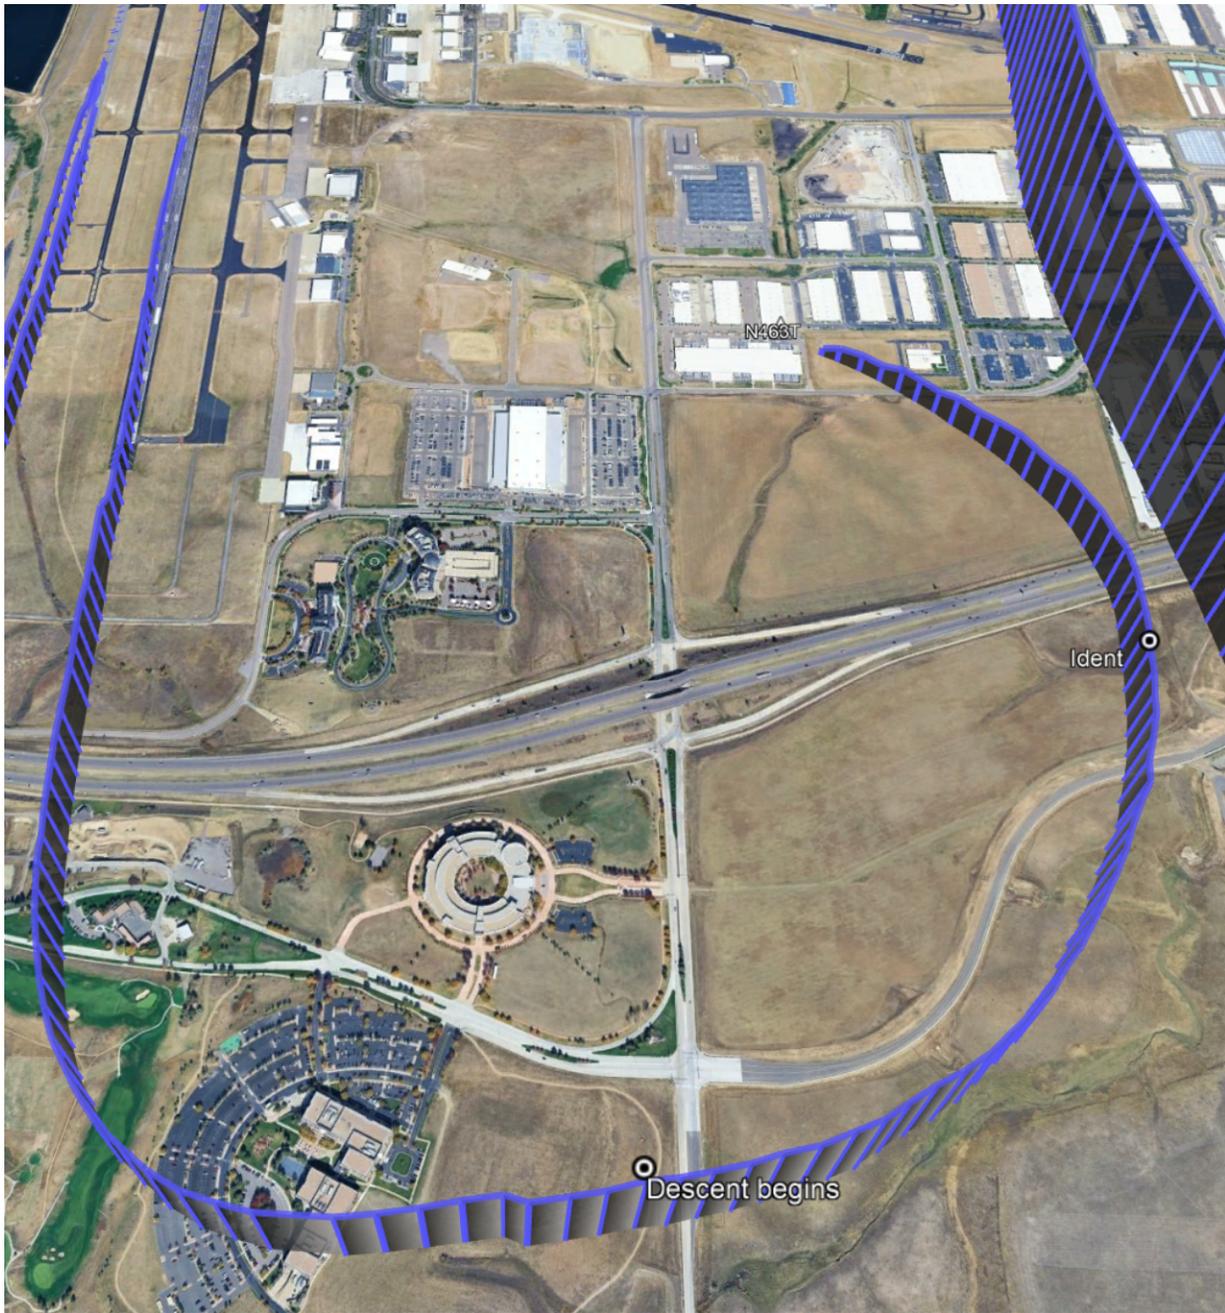
ADS-B data showed at 0622:15, the airplane stopped a climb and began to descend. At 0622:43, data recorded the airplane’s ident. The descent continued until the last recorded point of 0623:05 when the airplane was about 5,900 ft mean sea level, and 77 knots groundspeed.

Figure 1 ADS-B Data Plots with Accident Site (triangle)
