# Aviation Investigation Preliminary Report

| <b>Location:</b> | Roanoke, VA | <b>Incident Number:</b> | DCA25LA339 |
| <b>Date &amp; Time:</b> | September 24, 2025, 21:17 Local | <b>Registration:</b> | N21129 |
| <b>Aircraft:</b> | Embraer EMB-145XR | <b>Injuries:</b> | 53 None |

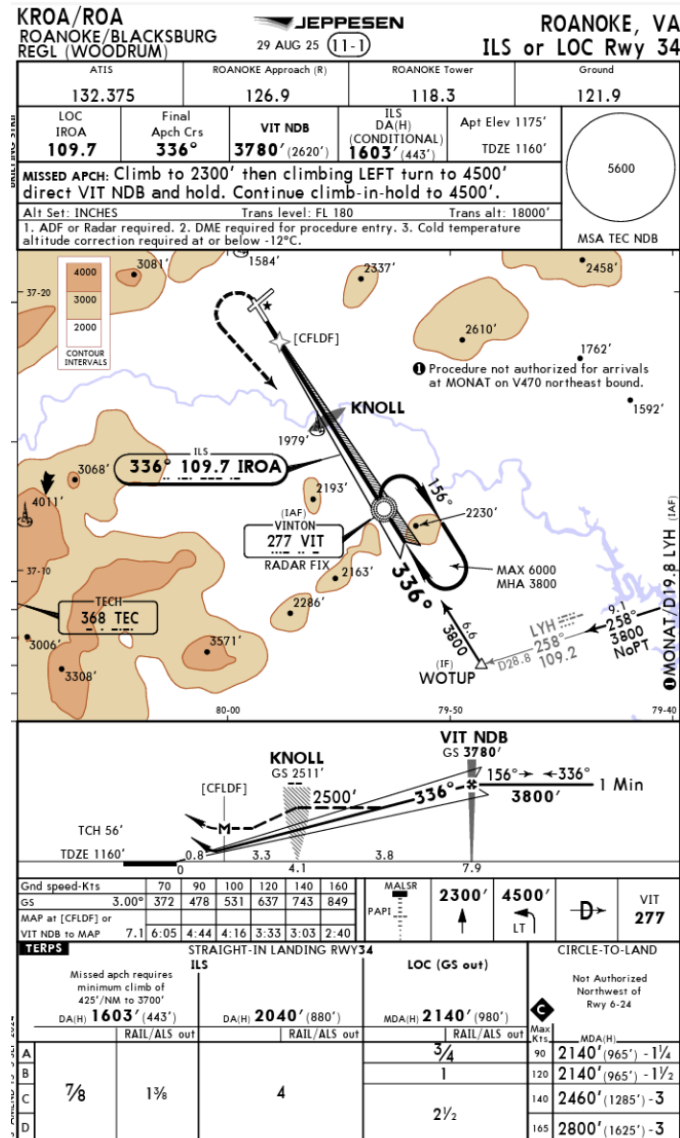
**Figure 1.** Jeppesen instrument approach plate for ILS runway 34 approach.
