# Aviation Investigation Preliminary Report

<b>Location:</b>	Parkin, AR	<b>Accident Number:</b>	CEN26FA010
<b>Date &amp; Time:</b>	October 6, 2025, 15:14 Local	<b>Registration:</b>	N9627X
<b>Aircraft:</b>	Cessna 210B	<b>Injuries:</b>	3 Fatal
<b>Flight Conducted Under:</b>	Part 91: General aviation - Personal

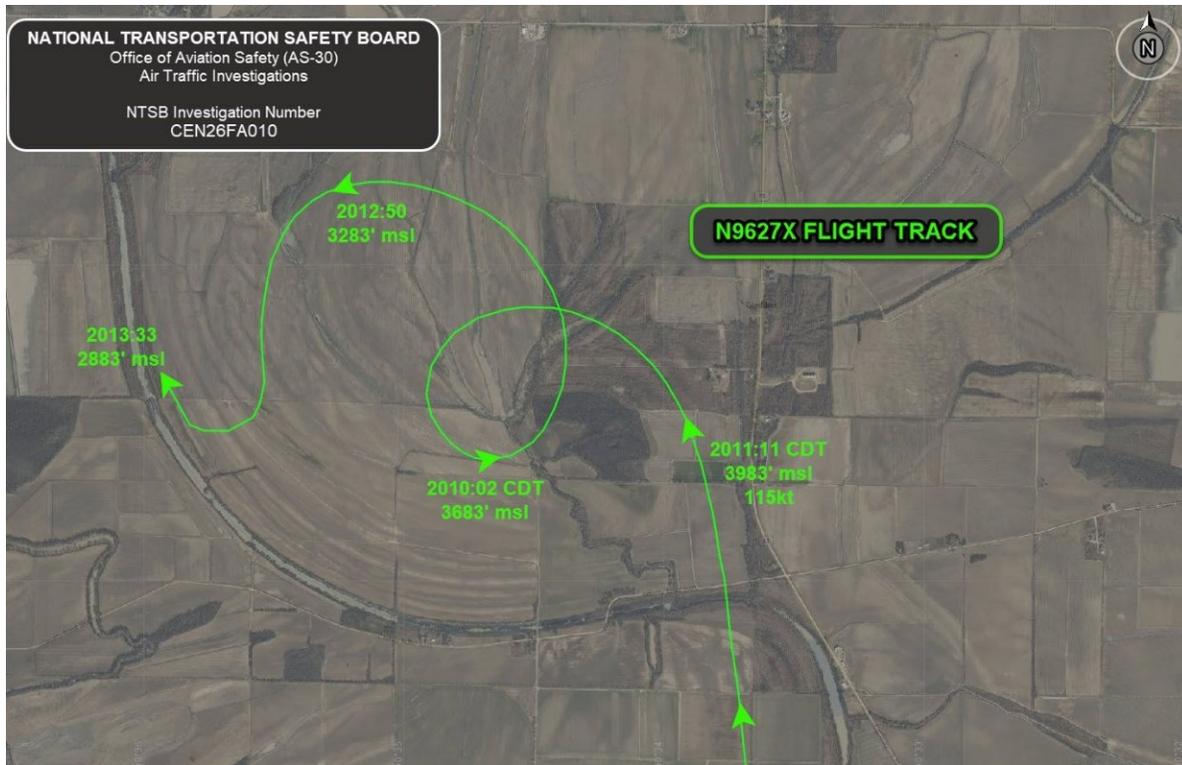
About 1511:07, the airplane entered a left turn. The airplane subsequently completed 1-1/2 full 360° turns until it was oriented on a southbound heading. The airplane altitude had decreased to about 3,300 ft msl. About 2 seconds later, at 1513:12, the airplane entered a right turn and appeared to remain in that turn until the final data point. The final ADS-B data point was recorded at 1513:33, and the airplane was on an approximate north heading at that time. The airplane altitude associated with the final data point was about 2,900 ft msl.

Figure 1 – Overview of flight track (vicinity of accident site)

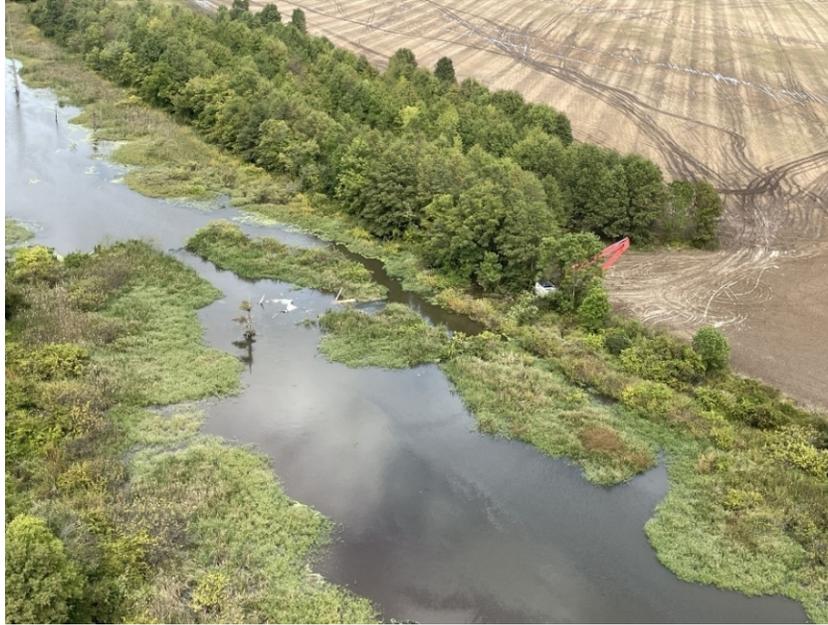
The accident site was located in a slough about 180 yards southwest from the final ADS-B data point at an elevation of about 200 ft. The main wreckage consisted of the fuselage, vertical stabilizer with rudder, wings, engine, and propeller. The aileron and flap remained attached to the left wing. The flap remained attached to the right wing. The outboard portion of the right wing was fragmented consistent with a right wing low impact. The right aileron was separated from the wing. The outboard portion of the aileron came to rest in a wooded area along the west bank of the slough about 50 yards west of the main wreckage. The right horizontal stabilizer with elevator attached was separated from the fuselage. It came to rest in a wooded area along the east bank of the slough about 45 yards northeast of the main wreckage. The left horizontal stabilizer was separated from the fuselage, and the left elevator was separated from the stabilizer. Both were recovered from the slough in the vicinity of the main wreckage.

A preliminary airframe examination revealed that the forward fuselage was separated and fragmented. The cockpit and cabin areas were compromised. The engine with the propeller attached was separated at the engine mounts. The fuselage was deformed along the entire length.

*Figure 2 -- Aerial view of accident site*

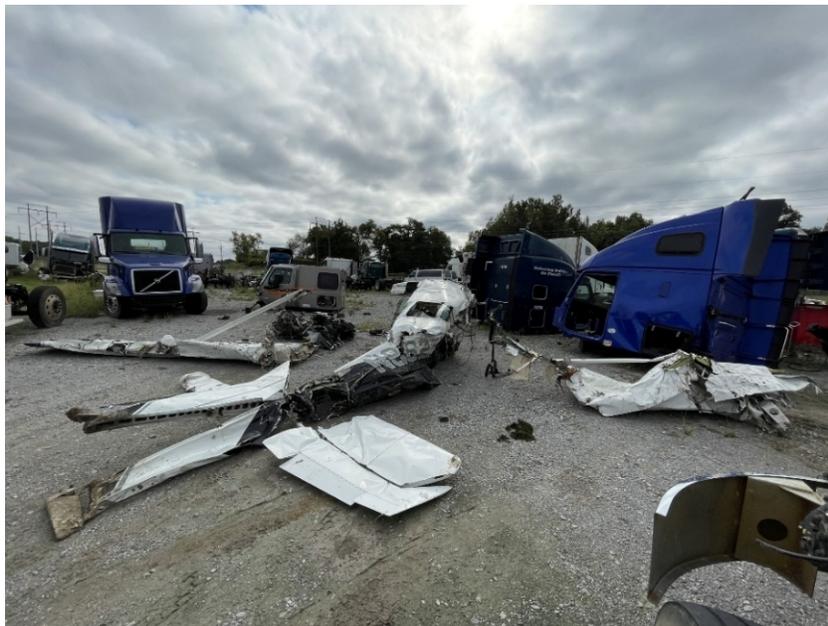
Flight control continuity was established to the extent possible. Specifically, elevator control continuity was confirmed from the cockpit torque tube to the aft fuselage. Rudder control continuity was confirmed from the cockpit rudder pedals to the rudder bellcrank. Aileron control continuity was confirmed from each wing bellcrank to the wing roots; although, the left aileron direct cable remained attached to the cockpit control column chain.

*Figure 3 -- Post-recovery view of airframe layout*

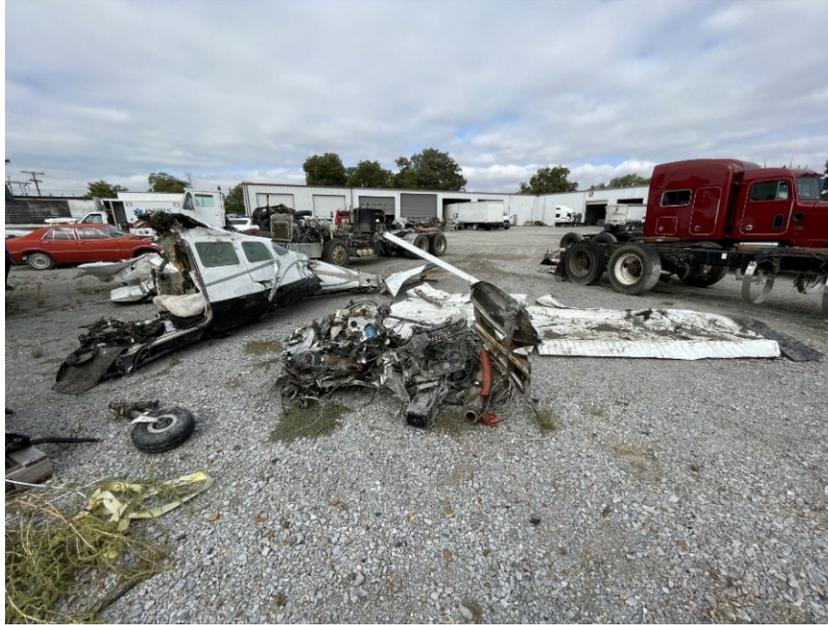
*Figure 4 -- Post-recovery view of airframe layout*

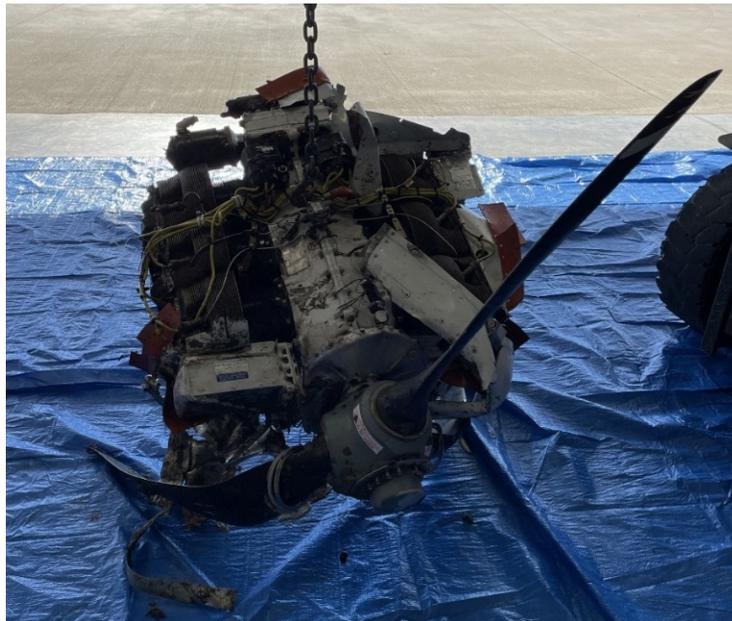
An initial engine examination noted damage to the engine assembly consistent with impact forces. Internal engine and accessory section continuity were observed during crankshaft rotation. Cylinder compression and suction were obtained at each cylinder. The left magneto provided a spark across all six leads. The right magneto provided a spark across three of the six leads. The engine induction and exhaust ducting were deformed consistent with impact forces.

*Figure 5 -- Post-recovery view of engine*

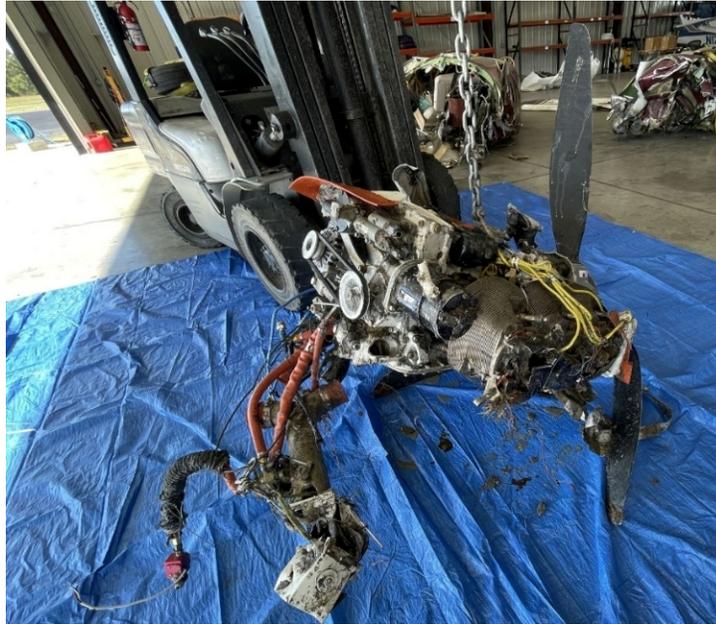
The engine-driven fuel pump was unremarkable, and the drive coupling was intact. The oil pump was separated from the engine case. Disassembly revealed the impellers and drive shaft were intact. The vacuum pump remained secured to the engine and appeared intact. The drive coupling was intact and rotated under hand pressure. Disassembly revealed that the vanes were intact.

*Figure 6 – Post-recovery view of engine*

The propeller remained attached to the engine, and the hub appeared to be intact. All three blades were retained by the hub. Blade A appeared intact. Blade B was bent aft about 90° over the entire span. The blade leading edge exhibited several leading-edge gouges. Blade C was bent aft about 80° near the root and exhibited small leading-edge gouges.
