# Aviation Investigation Preliminary Report

<b>Location:</b>	Skidmore, TX	<b>Accident Number:</b>	CEN26FA012
<b>Date &amp; Time:</b>	October 7, 2025, 12:23 Local	<b>Registration:</b>	N577B
<b>Aircraft:</b>	Beech A35	<b>Injuries:</b>	1 Fatal
<b>Flight Conducted Under:</b>	Part 91: General aviation - Personal

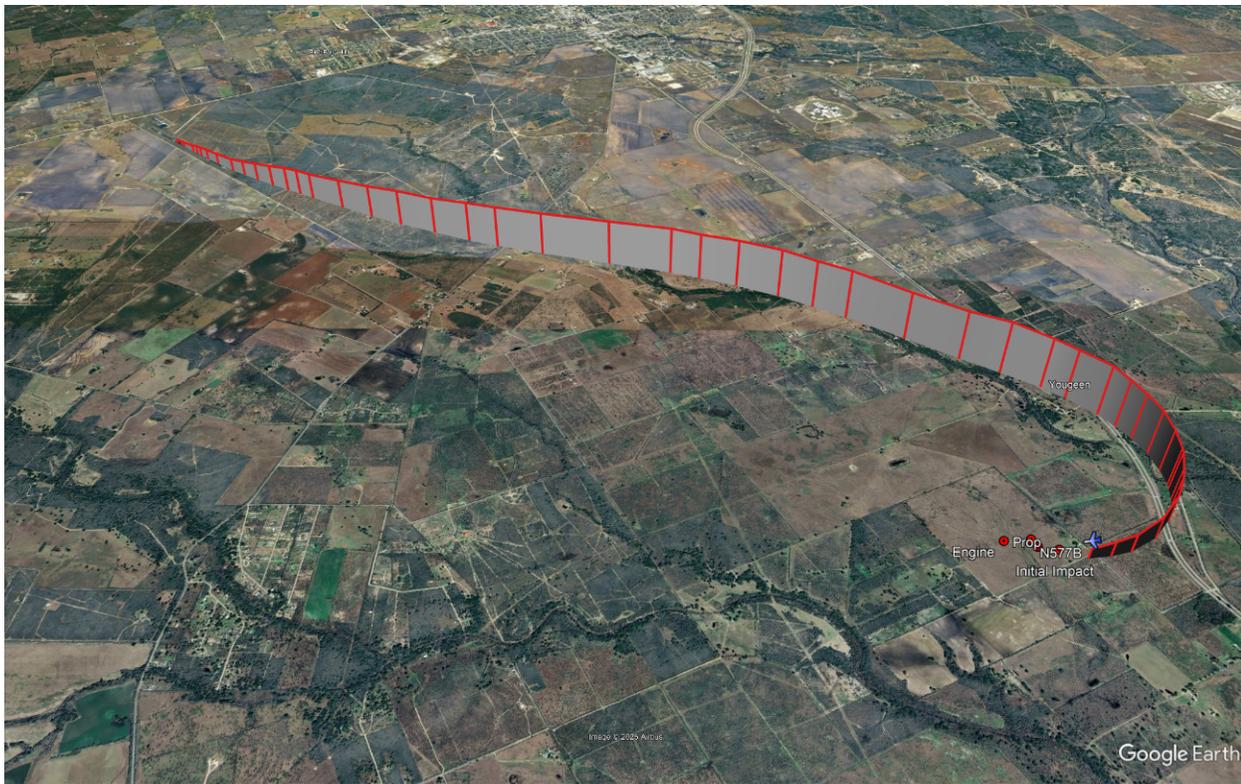
Preliminary ADS-B data indicated that the airplane departed from runway 12 at the Beeville Municipal Airport at 1219. After takeoff, the airplane climbed to about 1,600 ft. msl and then entered a descending right turn which continued to the accident site. The final ADS-B location, at 1223, was about 600 ft. east of the initial impact point. (see figure 1).

Figure 1. Three-dimensional view of the preliminary ADS-B track with accident location markers.
