# Aviation Investigation Preliminary Report

<b>Location:</b>	Lexington, SC	<b>Accident Number:</b>	ERA26FA106
<b>Date &amp; Time:</b>	February 6, 2026, 09:21 Local	<b>Registration:</b>	N705CD
<b>Aircraft:</b>	CIRRUS DESIGN CORP SR22	<b>Injuries:</b>	1 Fatal, 1 Serious
<b>Flight Conducted Under:</b>	Part 91: General aviation - Personal

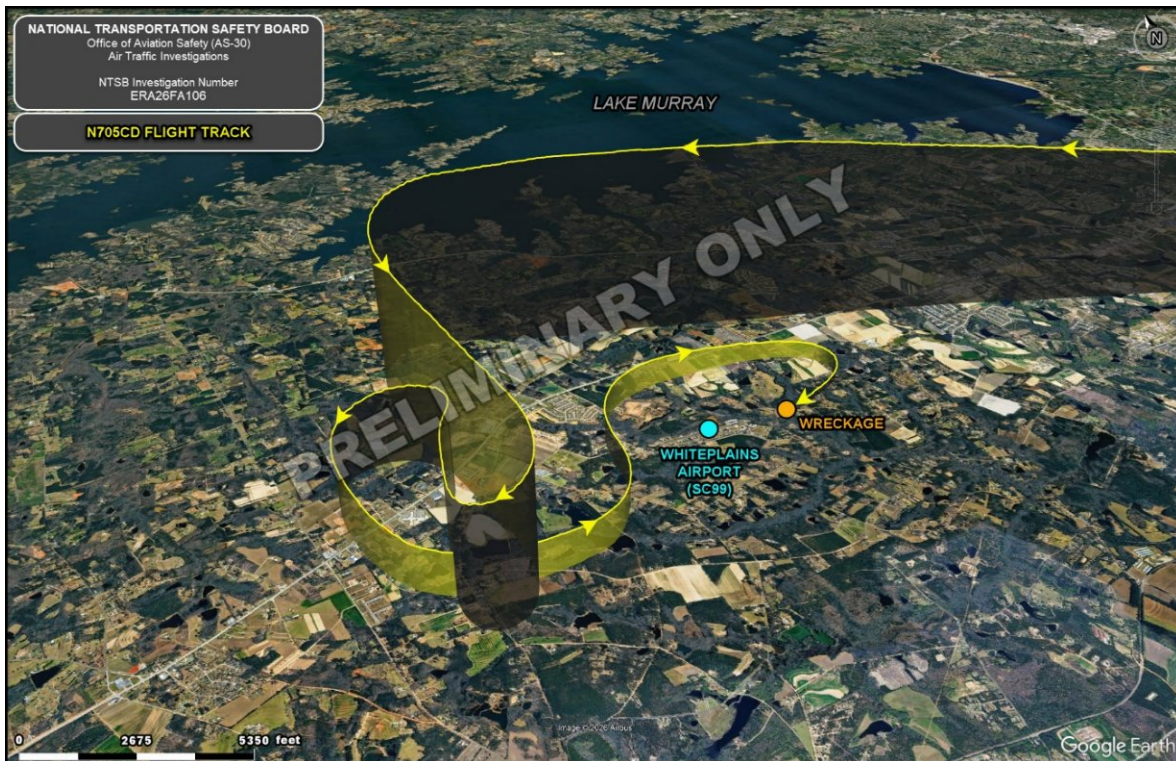
SC99 was a private airport community with a 3,000-ft-long paved runway configured in a 9/27 orientation, at an elevation of 524 ft. As the airplane flew past SC99, the pilot initiated a left turn toward the south while the airplane was descending through 6,400 ft msl. It remained on that track for about 2 miles before making a right teardrop turn toward the northeast, followed by a left teardrop turn to the south (see figure). The turning maneuvers were all conducted about 1 1/2-mile west of the airport before the pilot flew toward the airport and joined the right downwind leg of the traffic pattern for runway 27 at 1,600 ft msl (1,100 agl) and 120 kts groundspeed.

Figure - ADS-B flight track data for the final 8 minutes of the accident flight (yellow line) with SC99 (blue) and the accident site/wreckage annotated (orange).

The airplane's last ADS-B-observed position was recorded as it descended through 790 ft msl (about 300 ft agl), at 70 kts groundspeed, and about 2,100 ft east of the runway 27 threshold. Shortly after, the airplane impacted the top of 65-ft-tall pine trees about 1,000 ft from the runway threshold. The airplane rolled inverted and impacted a level gravel road before coming to rest against trees.
