# Aviation Investigation Preliminary Report

| <b>Location:</b> | Butler, MO | <b>Accident Number:</b> | CEN26FA224 |
| <b>Date &amp; Time:</b> | June 14, 2026, 11:25 Local | <b>Registration:</b> | N221BN |
| <b>Aircraft:</b> | PACIFIC AEROSPACE LTD 750XL | <b>Injuries:</b> | 12 Fatal |

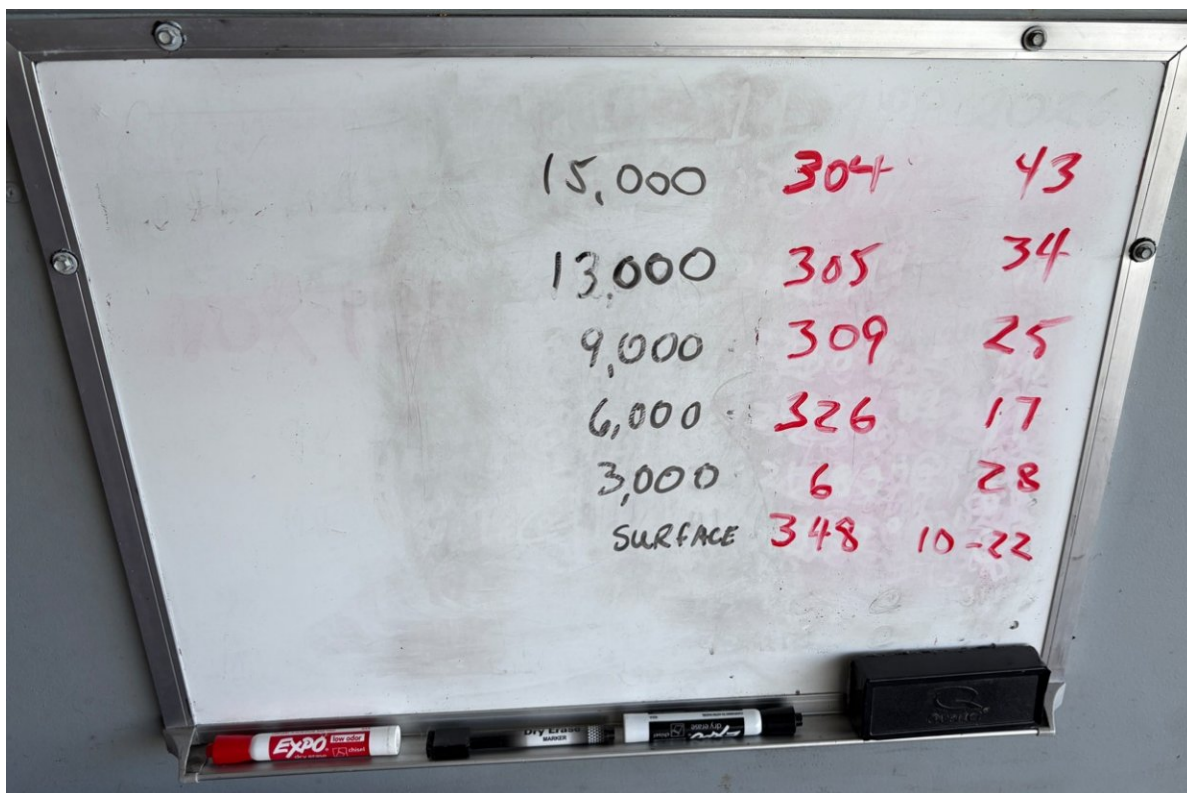
Figure 1. Image depicting the various wind speeds and directions on a whiteboard, for the different altitudes that the pilot researched and posted on the morning of the accident, located in the operator's building at BUM.

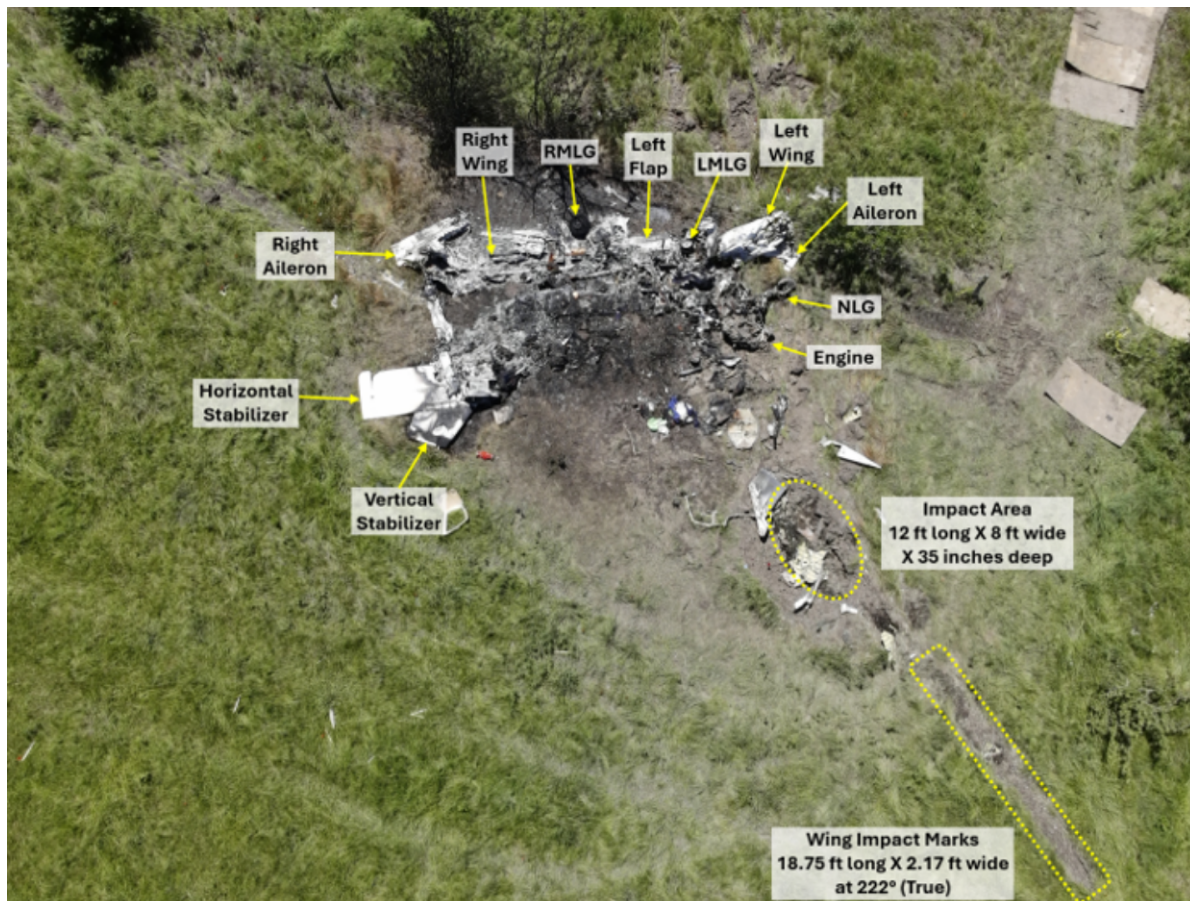
The accident site was located about 445 ft to the west of the southern end of the operator's LZ, near a north to south running barbed wire fence on BUM property. A postimpact fire consumed the wreckage.

Figure 3. Image depicting the wreckage at the accident site, with various airplane components labeled. Several airplane components were moved to facilitate the initial emergency response.

Postaccident examination of the airframe and engine revealed that all major structural components of the airframe were identified at the accident site; however, they had sustained significant thermal damage. Both the elevator and the rudder control systems sustained significant thermal damage. Measurements were obtained for the length of the flap gearbox jack screw extension, the length of the pitch trim actuator extension, and the length of the roll trim actuator extension to potentially determine the respective system positions at the time of the impact. The yaw trim system sustained significant thermal damage. The cockpit, the cabin, and the airframe fuel system all sustained significant thermal damage. The left and right direct aileron cables were removed and were transported to the NTSB Materials Laboratory for examination.
