# Aviation Investigation Preliminary Report

| <b>Location:</b> | Guymon, OK | <b>Accident Number:</b> | CEN26FA275 |
| <b>Date &amp; Time:</b> | August 2, 2026, 16:08 Local | <b>Registration:</b> | N210Q |
| <b>Aircraft:</b> | Beech E18S | <b>Injuries:</b> | 1 Fatal |

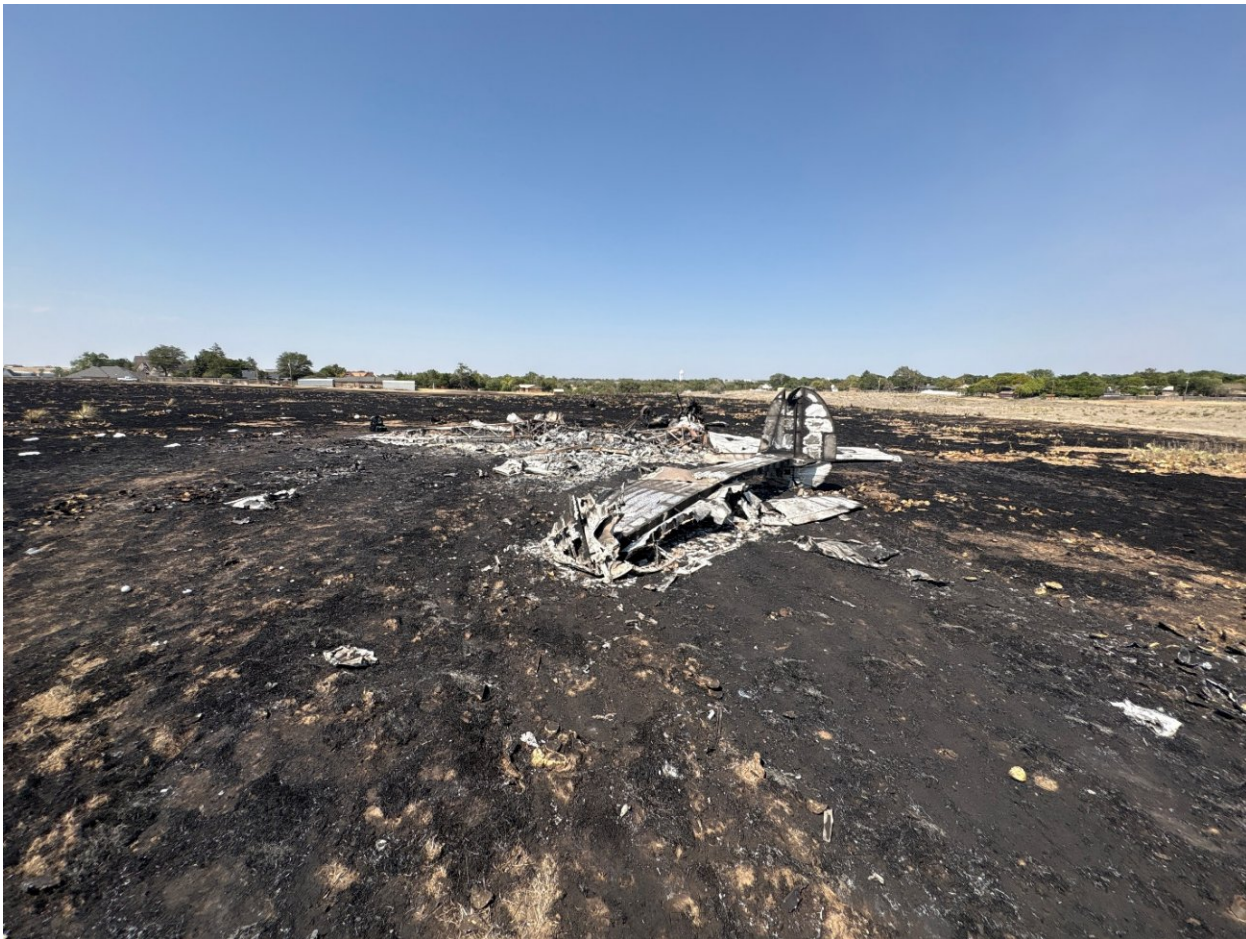
Figure 1. Main wreckage

The airplane impacted a grass covered field in a wings-level, flat pitch attitude on a heading of about 015°. The aircraft came to rest upright about 80 ft north of the initial impact point. A post-impact fire consumed the majority of the fuselage and melted the wings and tail as seen in figure 1. All major components of the airplane were identified. Both engines were separated from the airframe and located near the main wreckage. Both propeller hubs remained attached to the engines. The propeller blades showed varying degrees of bending, twisting, chordwise scratching and polishing. Examination of the flight controls found no evidence of preimpact mechanical malfunctions or failures that would have precluded normal operation.
