# Aviation Investigation Preliminary Report

<b>Location:</b>	Lafayette, LA	<b>Accident Number:</b>	CEN24FA353
<b>Date &amp; Time:</b>	September 12, 2024, 11:37 Local	<b>Registration:</b>	N643RS
<b>Aircraft:</b>	HAWKER BEECHCRAFT CORP G36	<b>Injuries:</b>	1 Fatal
<b>Flight Conducted Under:</b>	Part 91: General aviation - Personal

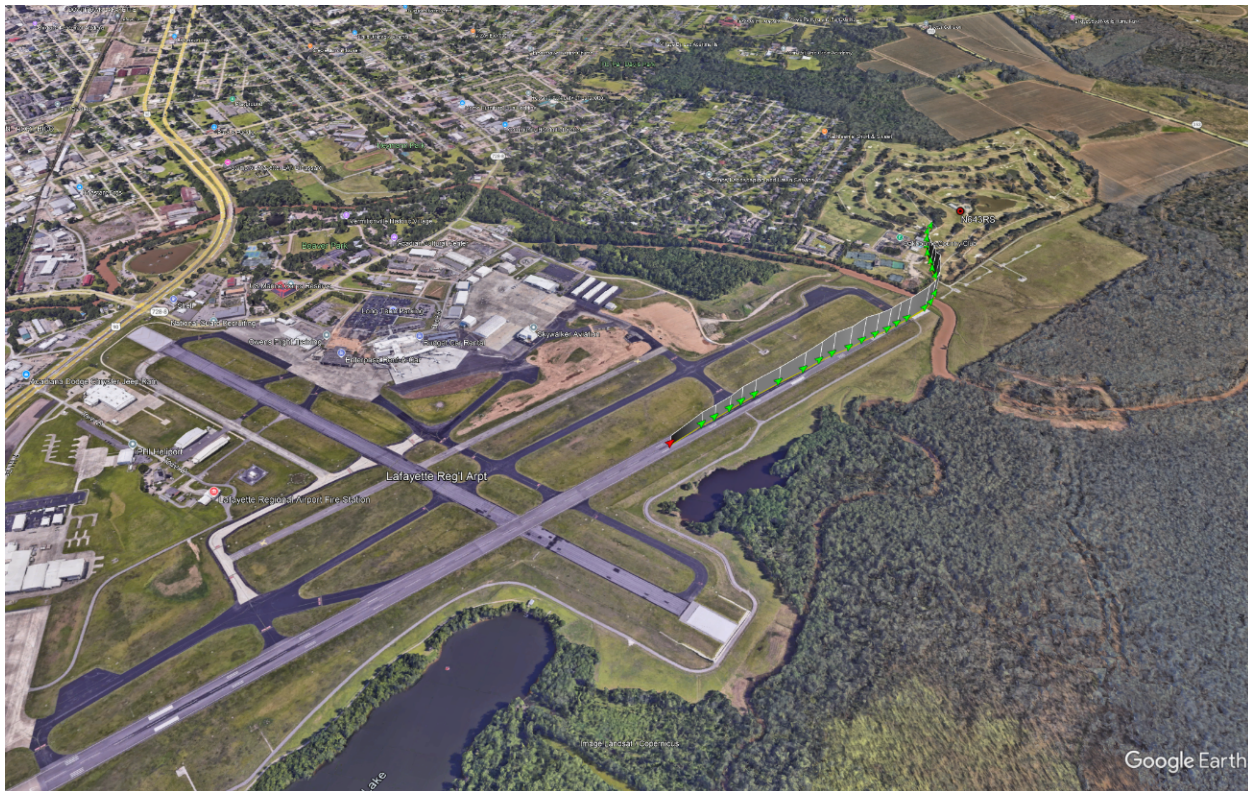
The airplane had just departed from runway 4R at the Lafayette Regional Airport (LFT), Lafayette, Louisiana. Automatic Dependent Surveillance-Broadcast (ADS-B) data showed that the airplane lifted off the runway and achieved an altitude of about 200 ft above ground level (agl) by the time it reached the departure end of the runway. The airplane then made a slight left turn followed by a right turn before the data ended. The final recorded altitude was 25 ft agl and the last recorded location was about 450 ft from the accident location. The airplane impacted a golf course about 2,000 ft and 15 degrees from the departure end of runway 4R.

Figure 1. A 3-dimensional representation of the airplane's flight path.
