# Thomas P. Turner's Mastery of Flight®

## FLYING LESSONS for July 3, 2025

### ***This week's LESSONS:***

#### **Everybody knows**

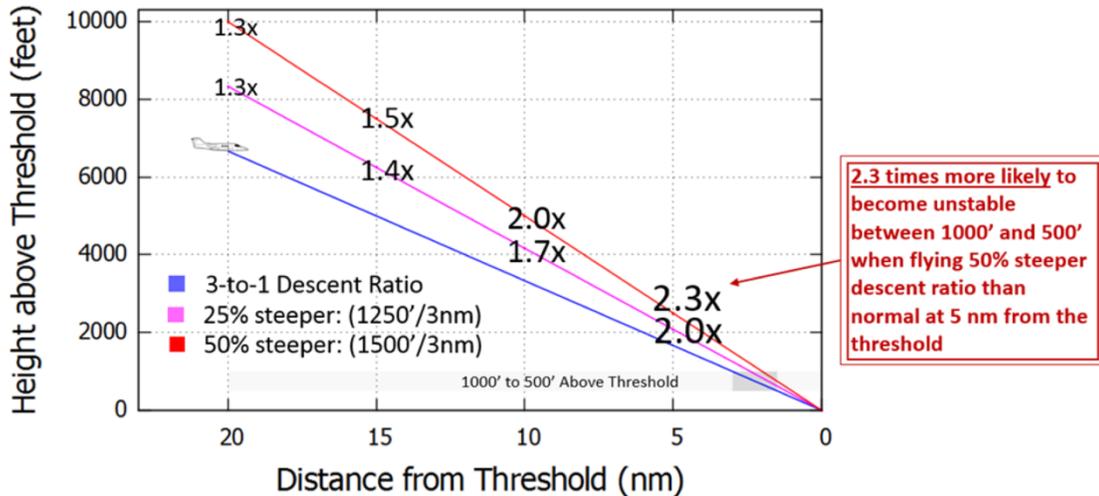
### Steep Descent Ratios Lead to Unstable Approaches

The FAA presents data (without citation) that illustrates a substantial increase in unstable approaches when attempting to fly glide angles steeper than three degrees.

The FAA likely feels the chances of accidents resulting from an unstable approach are greater than the chances from engine failure on final approach. That said, I think regular practice of power-off, short field landings—which follow a steeper-than-three-degree final approach, is a good way to ingrain the sight picture of an engine-out landing, as well as maintain muscle memory of rounding out from an engine-out landing whether it occurs to a runway or off-airport. Thank you, David, and thanks for your patience.
