# Aviation Investigation Preliminary Report

<b>Location:</b>	Covelo, CA	<b>Accident Number:</b>	WPR24FA018
<b>Date &amp; Time:</b>	October 20, 2023, 18:01 Local	<b>Registration:</b>	N8248K
<b>Aircraft:</b>	Beech A36	<b>Injuries:</b>	2 Fatal
<b>Flight Conducted Under:</b>	Part 91: General aviation - Personal

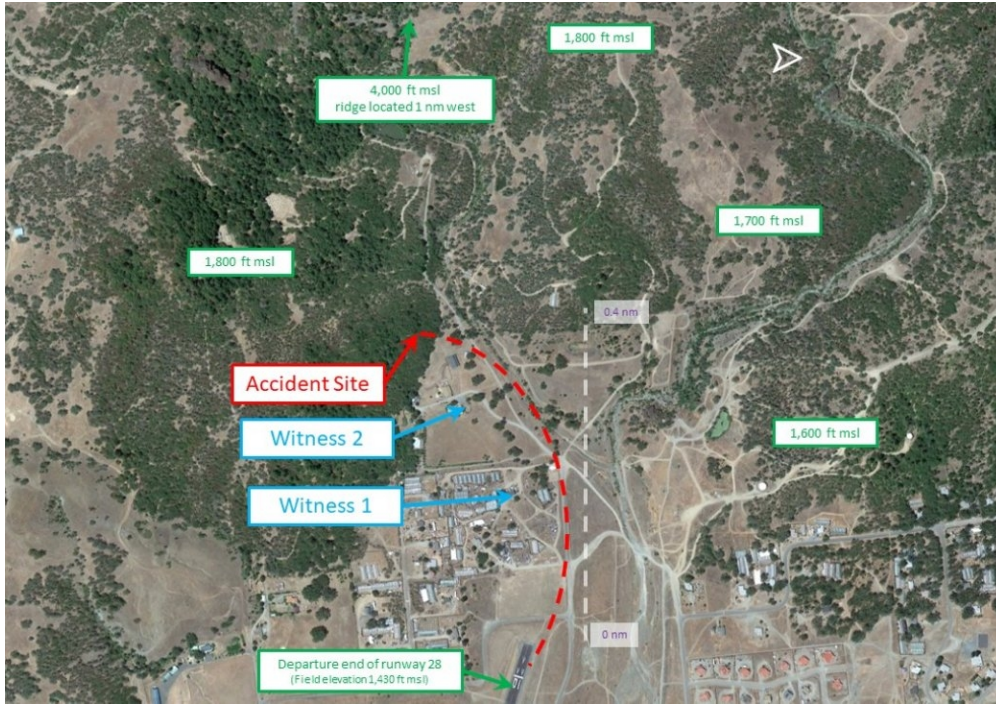
Figure 1: Flight path, accident site and surrounding terrain

According to a witness, the airplane lifted off the runway surface near the departure end of runway 28 at Round Valley Airport (009), Covelo, California. The airplane began a left turn towards the northwest in a nose high attitude before it disappeared from the witness' view. About this time, a second witness observed the airplane as it cleared a group of trees by about 20 ft while it continued its left turn in the same direction from about 60 ft above ground level. As the airplane turned towards the south its bank angle increased to about 70° and the airplane subsequently descended into the ground. The airplane exploded after it impacted the ground and a postcrash fire ensued.

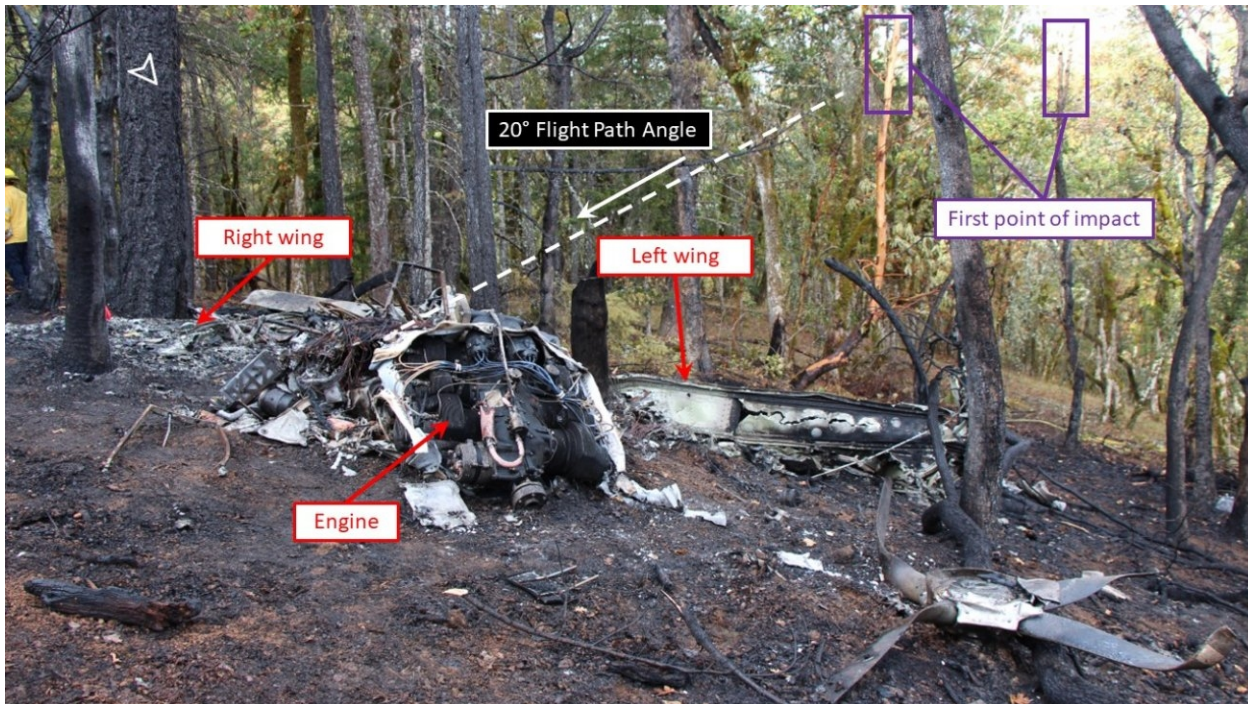
Figure 2: Accident site with flight path angle

The airplane came to rest on a hillside about 0.40 nm west of the departure end of runway 28 at a field elevation of about 1,500 ft mean sea level oriented on a northeasterly heading. The airplane's major structures were all accounted for at the accident site. The first point of impact (FPI) was marked by several trees about 20 feet tall with broken tree tops and broken branches at the base of each tree. A 50 foot long debris path was traced from the FPI to the main wreckage, which was mostly consumed by postcrash fire.
