# Aviation Investigation Preliminary Report

<b>Location:</b>	Gustavus, AK	<b>Accident Number:</b>	ANC24LA069
<b>Date &amp; Time:</b>	July 20, 2024, 14:21 Local	<b>Registration:</b>	N410B
<b>Aircraft:</b>	Beech A35	<b>Injuries:</b>	3 Fatal
<b>Flight Conducted Under:</b>	Part 91: General aviation - Personal

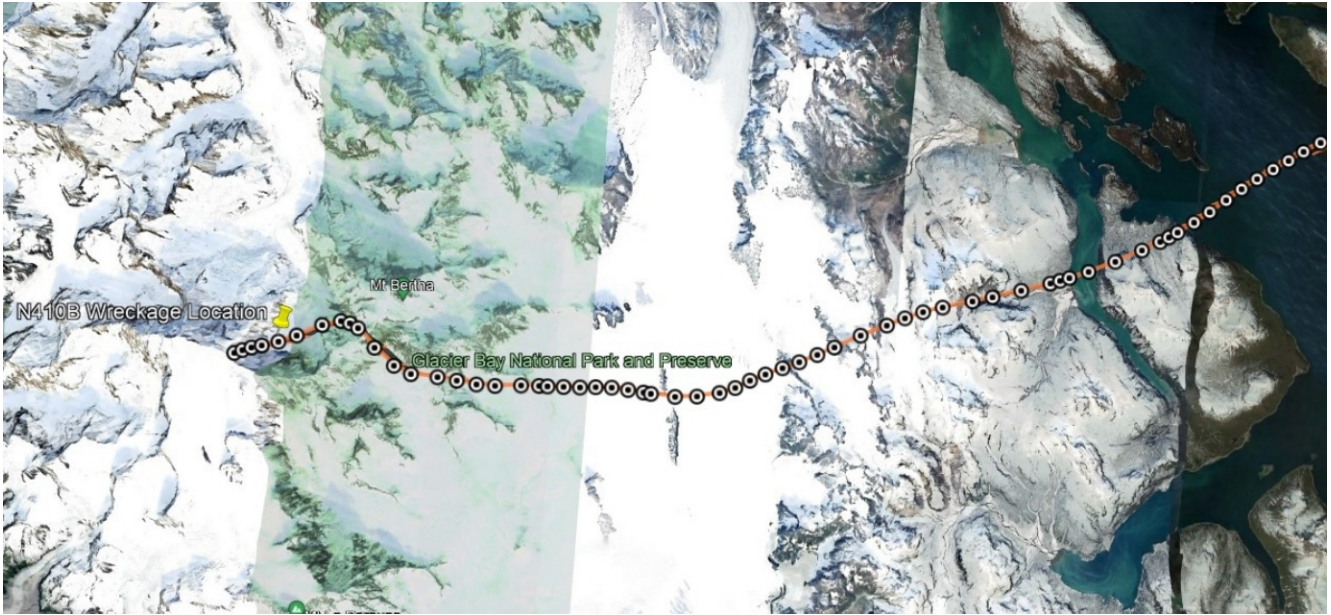
**Figure 1: Accident airplane’s ADS-B track through Glacier Bay National Park**

According to FAA archived Automatic Dependent Surveillance–Broadcast (ADS-B) data, the accident airplane departed Juneau about 1344 and initially headed northwest for about 72 miles. The airplane’s track then changed direction to a southwesterly heading and began flying through the mountainous terrain of Glacier Bay National Park for an additional 30 miles. (See Figure 1)
